INEEL/EXT-99-01302

# **Light Duty Utility Arm Deployment in Tank WM-188**

**Published December 1999**

**Idaho National Engineering and Environmental Laboratory  
Idaho Falls, Idaho 83415**

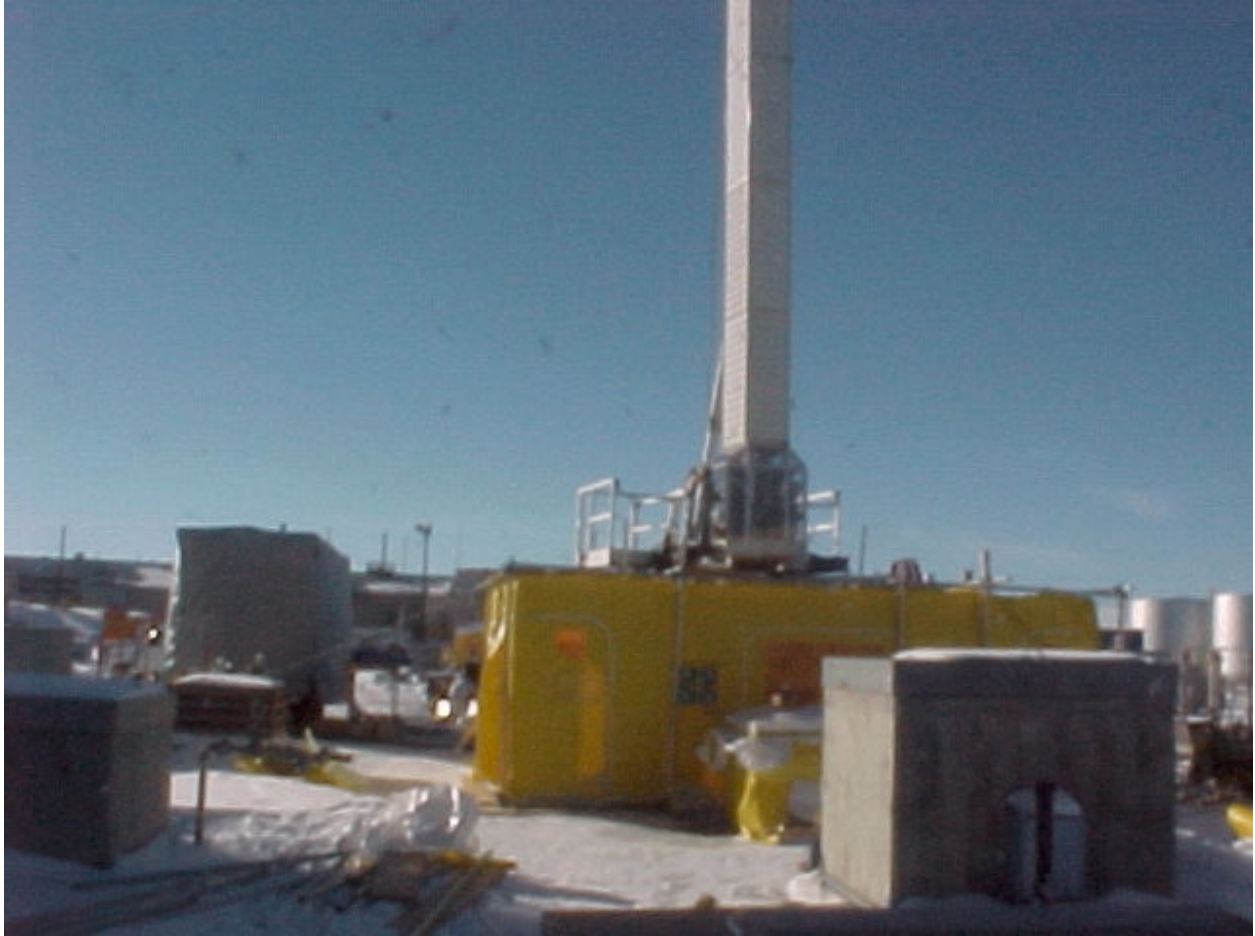
From February 2 to February 5, 1999, the major pieces of LDUA equipment were moved to the tank farm. Equipment checkout, functional tests, and operability checks were performed. Troubleshooting and testing were performed from February 8 to February 10. Equipment setup included all of the cold weather controls, radiological tent construction over the riser, laser alignment of the tank riser, and insertion of an auxiliary camera in adjacent riser TR-27, which is approximately centered in the tank.

**Figure 1.** LDUA Deployed over Tank WM-188.

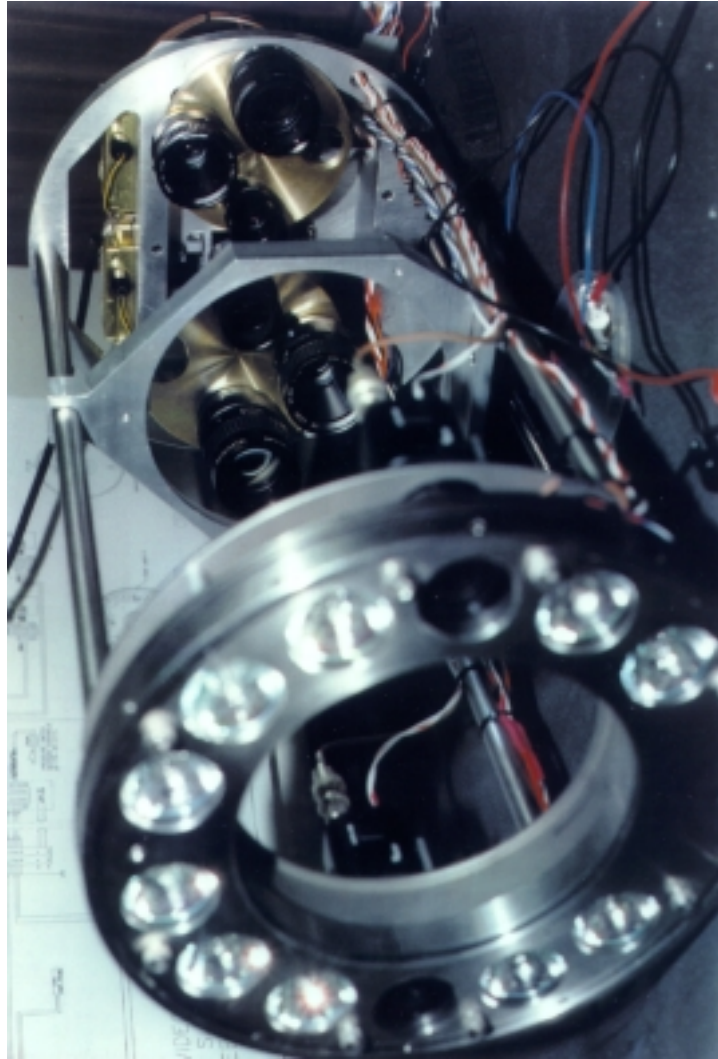
**3.1.3.1 High Resolution Stereo Video System End Effector.** The High Resolution Stereo Video System (HRSVS) end effector provides a three-dimensional image for inspecting tank interiors and waste. A special lens system provides zoom capabilities. At any standoff distance, the size of the viewing area is known, which allows accurate sizing of the subject.

**Figure 2.** HRSVS End Effector.

The lens system uses a pair of color video cameras that provide a stereoscopic image to aid in the differentiation between pits and bumps. Fixed intensity lights in the lighting system can be turned on and off in pairs to shadow the viewing area, further improving the operator's perception. Two additional cameras with separate fixed focus lenses provide an overview and are used to guide the arm to an area for closer inspection.

**NOTE:** The HRSVS was modified because the cameras and lenses could not be kept in focus and alignment—the cameras were hard mounted inside the end effector housing, eliminating focus and zoom capabilities. The components are fixed, so focusing is achieved by moving the arm.

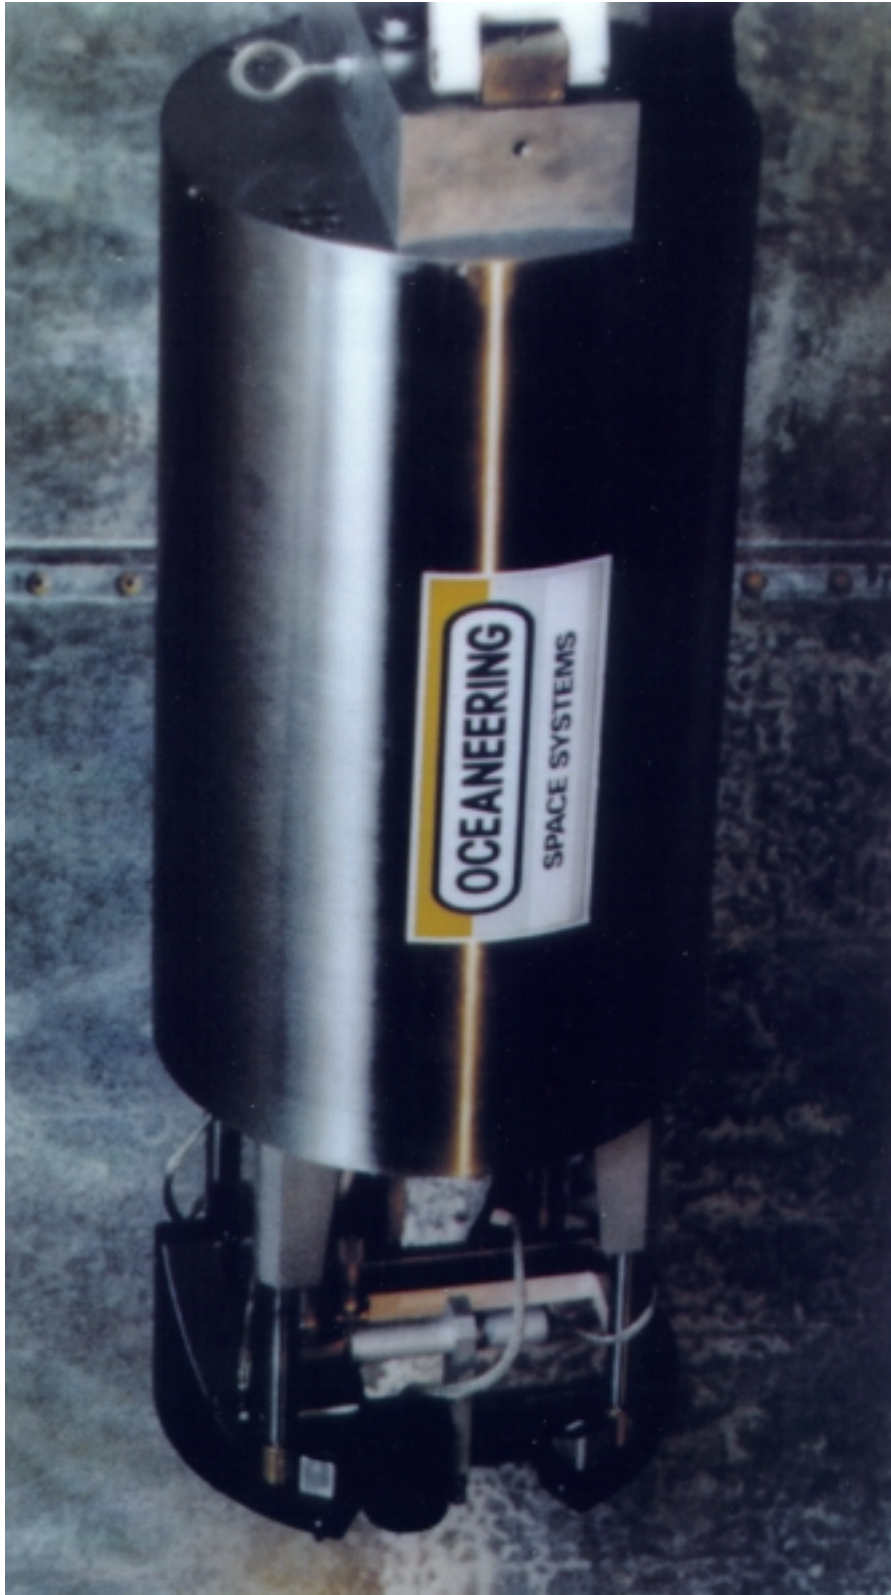
**3.1.3.2 Alternating Current Field Measurement End Effector.** The Alternating Current Field Measurement (ACFM) end effector was developed by Oceaneering Space Systems, Inc., of Houston, Texas, in cooperation with the Federal Energy Technology Center (FETC), and is used to support evaluations of the structural and containment integrity of the tank. It was designed to perform a “flyby” scan of the tank surfaces and identify suspect areas for more detailed examinations. Additionally, the end effector was modified for submersion in liquids (this feature was tested before deployment but was not performed in Tank WM-188).

**Figure 3.** ACFM End Effector.

The ACFM End Effector detects and measures cracks, wall thickness, and pits in stainless steel walls and tank wells. The flyby resolution of the end effector for cracks is 0.5 inches long and 0.25 inches deep. For pits, the resolution is 0.25 inches in diameter and 0.25 inches deep. Measurements are made based on changes, induced by defects in the measured surface, in an electromagnetic field. The field is created by the alternating current in the scanning head. (Conventional NDE methods in the United States are based on eddy current technology, although alternating current is used widely in Europe. Part of OSS's purpose in developing the end effector was to demonstrate the technology in the United States.)

**NOTE:** The flyby capabilities of the ACFM End Effector were not used or tested because the INEEL NDE End Effector was not available for confirmation and comparison of data.

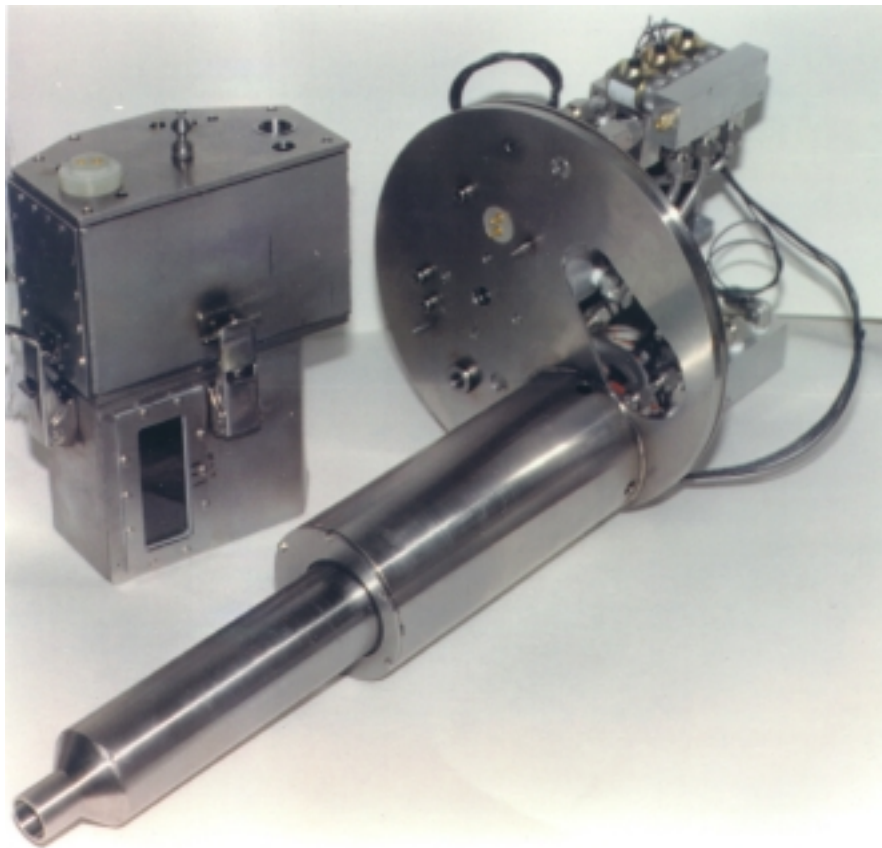
**3.1.3.3 *Sampler End Effector.*** The Sampler End Effector was designed and fabricated at the INEEL, and includes a camera, variable intensity lights, a radiation detector, and the sampling system. The sample system establishes a vacuum in the sample chamber, then pulls waste into the chamber when the valve between the chamber and tank heel is opened. Solution is drawn to the sample chamber through a capture tube that is inserted in the waste, while the sample chamber remains suspended above the liquid heel. A picture of the Sampler End Effector is shown below.

**Figure 4.** Sampler End Effector.

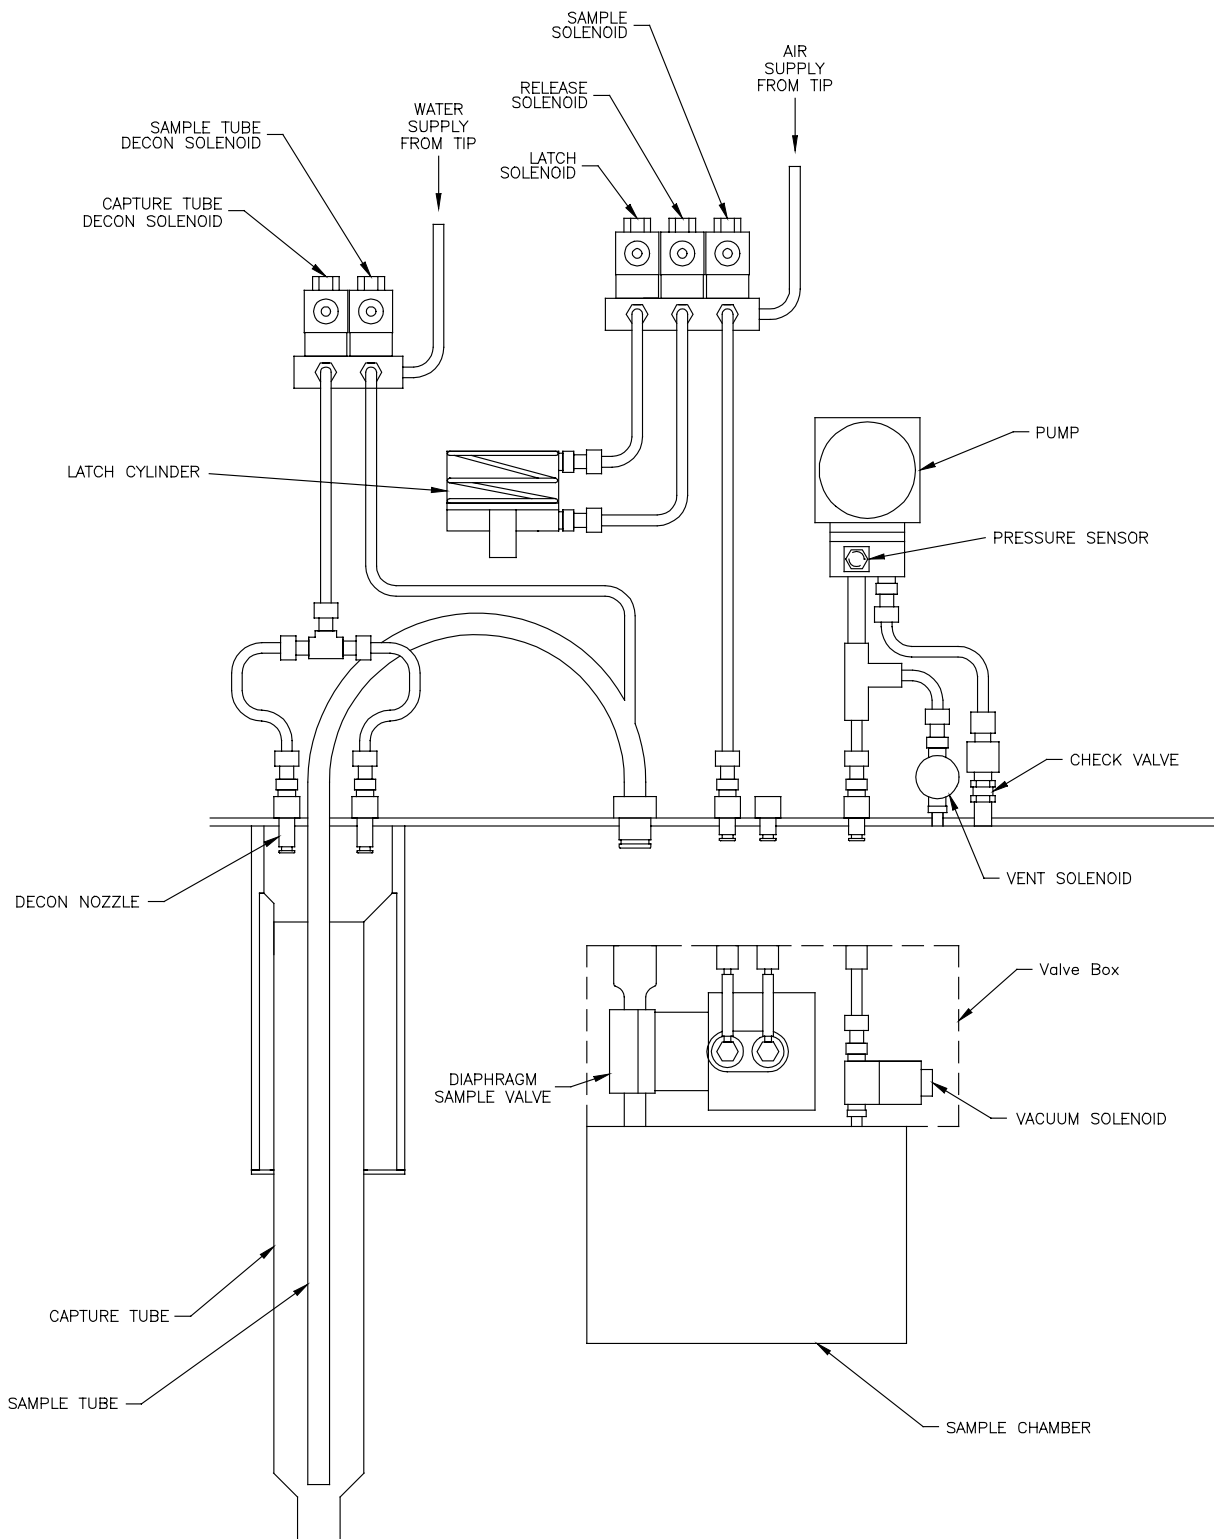
**Figure 5.** Sample System Schematic.

Two methods are used to control the sample volume. In the capture method, the capture tube is seated on the bottom of the tank. The sample volume is essentially the solution inside the capture tube, and the volume sampled is proportional to depth of the heel. In the volume method, the capture tube is lifted off the bottom of the tank and the sample chamber vacuum determines the sample volume. When the isolation valve is opened, solution is drawn into the sample chamber until the pressure in the chamber equalizes with the tank pressure. The relationship between vacuum and volume is known and controlled by the operator in the control trailer. A schematic of the sample system is shown below.

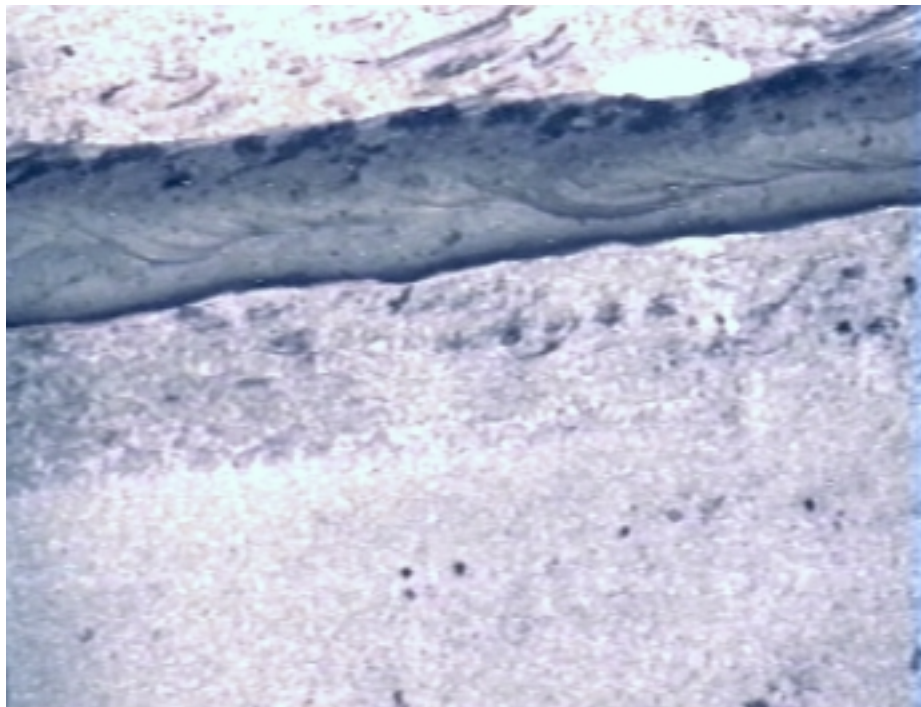
The tank wall, cooling coils, internal piping, supports, and welds were visually inspected. Approximately 25% of welds were evaluated. A typical welded bracket for cooling coil support and typical tank weld are shown below.

**Figure 6.** Typical Welded Bracket and Tank Weld<sup>16</sup>

All of the equipment inspected showed little or no indication of corrosion. Small, localized pitting was observed as noted above, which was attributed to fabrication. Grinding patterns and other marks from fabrication are still readily apparent on the tank wall. They show no sign of deterioration or propagation. None of the observations indicate that the tank's integrity is suspect.

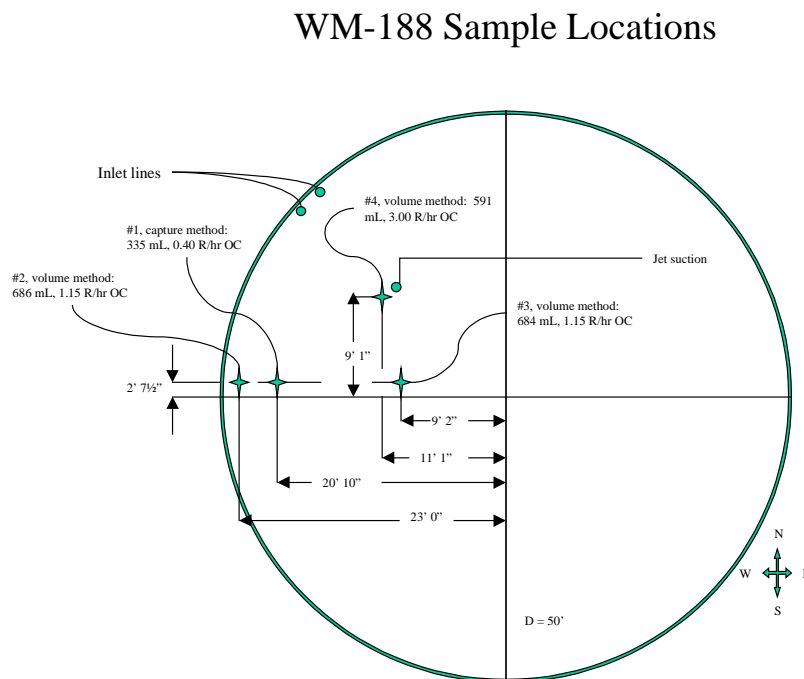
The diagram below shows the location of all four samples in Tank WM-188. The distances shown are approximate.

**Figure 7.** WM-188 Sample Locations.
